# LANDSLIDE RISK AT INCA'S WORLD HERITAGE IN MACHU PICCHU, PERU

## 世界遺産マチュピチュにおける地すべり危険度評価

Kyoji SASSA, Hiroshi FUKUOKA, Toshitaka KAMAI and Haruo SHUZUI

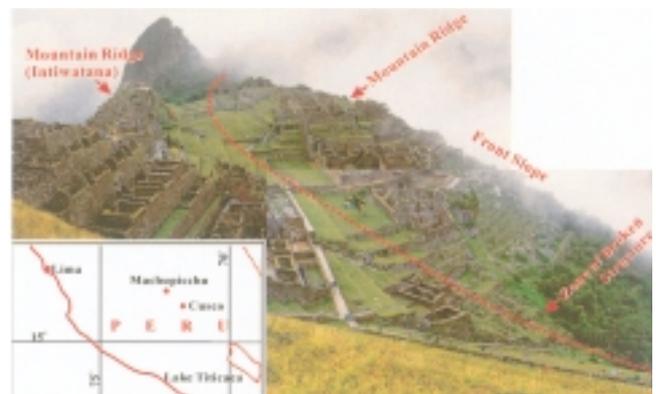
Fig. 1 Location and view of Machu Picchu Inca Citadel, Peru

Fig. 1 (photo) presents the Inca Citadel at Machu Picchu. The citadel was constructed on top of a mountain. The east slope (at the right side of the photo) is relatively gentle, and the access road (H. Bingham Road) and sightseeing hotel are constructed in this side of the slope. We call this side of slope as *Front Slope*. As reported in Carreno and Bonnard (1997), the *Front Slope* is the dip slope, in which the joints of the rock mass are aligned almost parallel to the slope. In this slope, we found a "zone of broken stone structure," as indicated in Fig.1. The stone structures seemed not so strong type there, but still the zone of broken structures is likely to be a shear zone of a potential landslide in the precursor stage.

Surface extensometers are sensitive and reliable monitoring instruments. At least several extensometers should be installed. A series of extensometers should be positioned crossing the possible shear zone of the "zone of broken structure" shown in Fig. 1, and also on the head scarps of landslides (Blocks No. 4, 5, 6) on the Back Slope to check retrogressive movement at the citadel.

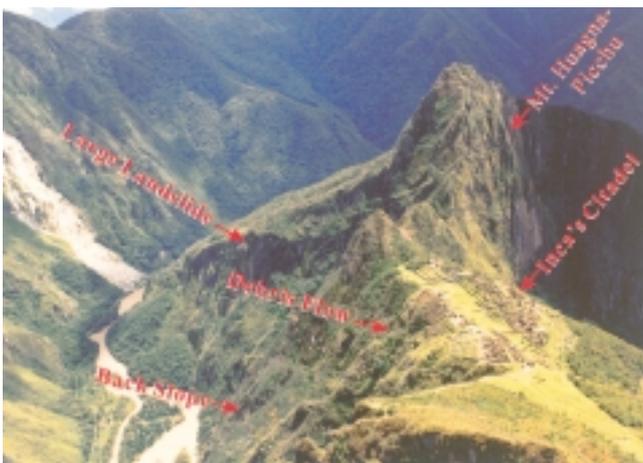
The other side (west side) of the mountain is very steep, and has no access road from the Urubamba river to the Inca Citadel. We call this slope the *Back Slope* (Fig. 2). The *Back Slope* is a cross-dip slope, and has a high resistance to shear. As a result, the slope angle is very steep. However, there are many large and small pre-existing landslides. The landslide marked by an arrow in Fig. 2 is large and relatively young. The white trace in the opposite bank is the deposit of a recent landslide. Most landslides on the *Back Slope* are rock falls or topples.

Fig. 2 Inca Citadel and the Back Slope.  
(Taken from a chartered helicopter by K. Sassa on 19 March 2000)

We found the trace of a very recent small debris flow on the back slope of Intiwatana ridge (symbolic, most popular and the highest part of the Citadel; see Fig. 1). However, the debris flow trace is not visible in the photo of Fig. 2 because it is behind a small ridge. The location is marked "debris flow" in

Fig. 2. A line of cracks and deformation of structure (Principal Temple) was found in other side. Therefore, the block that includes Intiwatana is expressed as a potential landslide block (No. 5) in Figs. 4, 6 and 11.

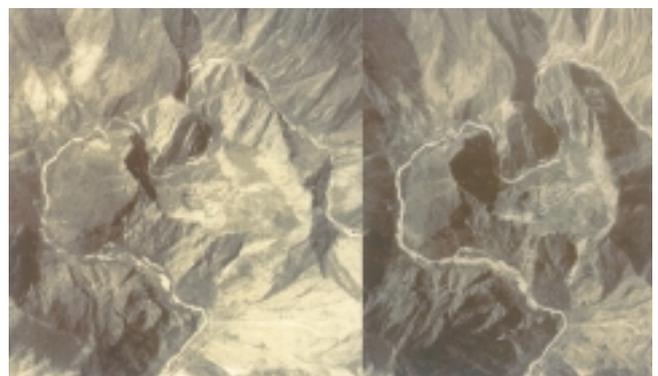
Fig. 3 is a stereo pair airphoto of the entire Machu Picchu area. The access road (H. Bingham Road) climbing up to the Inca Citadel is easily visible. In addition, the area shows the form of a large-scale landslide. The Urubamba River makes an almost full turn around this area. The influence of the fault system is very strong. Mount Putukusi on the opposite side of H. Bingham Road may seem to be the displaced landslide mass in this photo, but it is at almost the same elevation as the citadel. The base of the mountain seems to be intact, although its surface has been modified by rock slides. This photo has been published previously in *Landslide News* No.10 (Carreno and Bonnard 1997).

Fig. 3 Airphoto of Machu Picchu.  
(By the Geographical Institute, Peru on 28 July 1963)

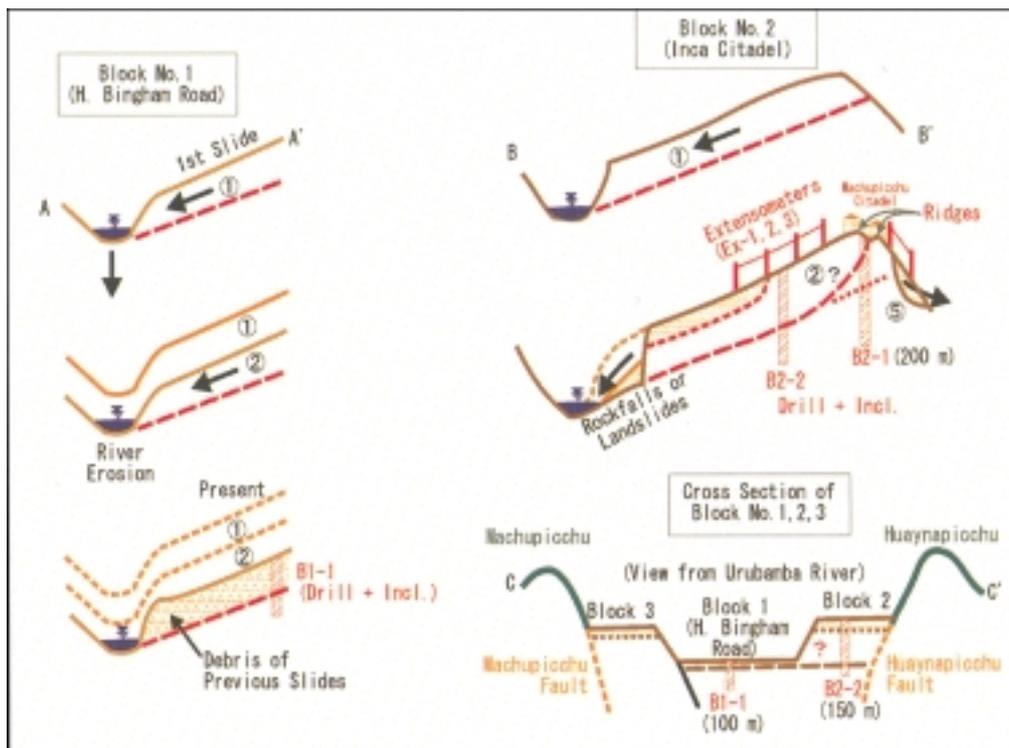
A hypothesis for the slope evolution at Machu Picchu as obtained from the field investigation and airphoto interpretation is explained using Figs. 4, 5, and 6. Fig. 6 illustrates the slope evolution (in the sense of working hypothesis) along schematic sections A-A' of Block No. 1 and B-B' of Block No. 2. The locations of these sections are shown in Fig. 5. The slope of Machu Picchu slid along joint in granite that are inclined toward the Urubamba River at depth. As shown in Fig. 4, the sliding surface of the 1st slide in Block No.1 is likely to be at the present ground level of Block No. 2 including the Inca Citadel and its farm area, and also at the present ground level of Block No. 3 (see section C-C' at the bottom right of Fig. 6). The second landslide occurred in Block No. 1 due to river erosion and the lowering of the level of the river bed. The present situation at Block No.1 seems to be a "reactivation" of this earlier landslide mass. The previous landslide in Block 2 removed the mountain ridge (Fig. 3) and formed topography suitable for construction of the citadel. Similar to the case at other landslide areas, landslide activity formed a relatively gentle slope and soils suitable for farming in this rocky area.

Fig. 6 Hypothesis of the landslide process in Machu Picchu.

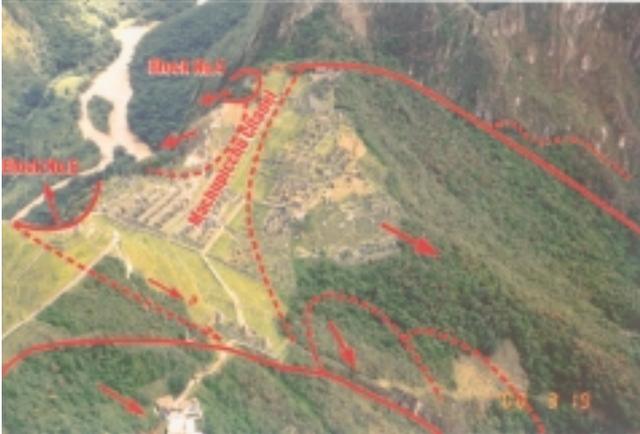
Fig.7 is an oblique airphoto of Block No. 2 and the Machu Picchu Citadel, it shows some part of landslides and potential landslides of Fig. 4. Block No.1 is a reactivated landslide; the landslide topography is visible, the border being indicated by a solid line. Another long solid line at the top of the figure is the Hynapicchu fault, between the rock cliff and the forest. This was the border of the first landsliding which removed the mountain ridge at this location and provided a site suitable for the citadel. The possible head scarp, forming a double ridge

Fig. 7 Oblique airphoto of the Inca citadel, indicating delineation of existing and potential landslides.

crossing the central flat area of the citadel is expressed as a dotted line. Block No. 5 including "Intiwatana," the highest point of the citadel is surrounded by a dotted line. There is also the possibility that the entire block, including the citadel, may slide along the rock joint in the same way as the sliding in Block No. 1, or previous landsliding in Block No. 2. All dotted lines are still hypothetical, and need additional study.

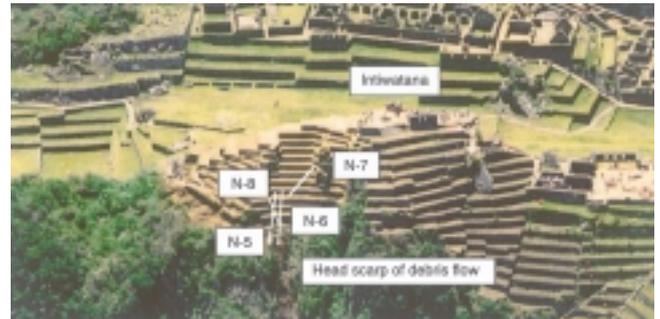
Fig.10 Location of the four sets of simplified type extensometers (N-5,6,7 & 8) installed in the Back Slope beneath the Intiwatana at risk of retrogressing landslide.

from the helicopter in March 2000, a debris flow was observed on the *Back Slope* just beneath the peak of the Intiwatana ("Head scarp of debris flow" in Fig. 10). The head scarp of this debris flow has obviously retrogressed and it has become visible from the peak of the Intiwatana in 2000. It is certain that the next retrogressive failure will give damage to the steps of the back slope of Intiwatana. These steps might be restored after Bingham's discovery by the Peruvian government. This slide is most significant among all of the potential landslides in Machu Picchu citadel. Four sets of non-recording type extensometers were installed on the back slope of Intiwatana for monitoring the reactivation of debris flow as well as the possible instability of the lower steps on the back slope (N-5,6,7&8 in Fig. 10). Two of the spans connected from inside of the debris flow head scarp to the artificial step beneath Intiwatana. Other spans connected lower step to higher ones. If the instability of the steps become obvious, urgent remedial work would be necessary.

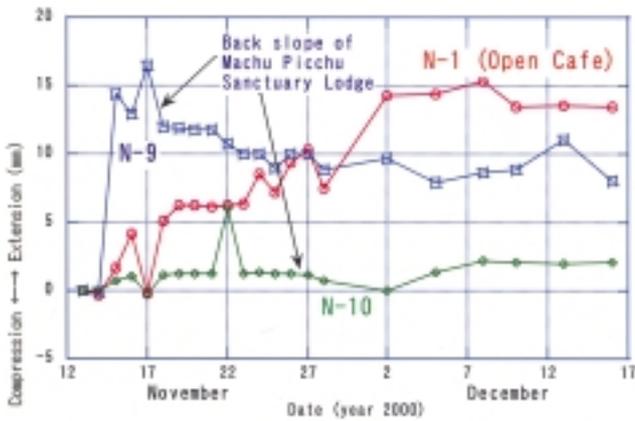
Observed data of the non-recording extensometers are shown in Fig. 12. The extensometer at the open cafe showed almost cumulative extensive movement of about 15 mm in this period. Extension was expected at this site because the extensometer span was installed at the head of a small landslide scarp. The extension of the first week (about 5 mm) might be caused by stretching of super-invar wire itself due to loading by weight. However, about 10 mm of further cumulative movement still continued thereafter. This movement might be interpreted as a

Fig.12 Monitoring record of the simplified extensometers before the open cafe and back slope of the Machu Picchu Sanctuary Lodge.

result of landslide activity because the 10 mm movement is larger than scattering of 3 - 5 mm. In Machu Picchu district, the rainy season is from December to March, however, precipitation record is not yet obtained and cannot be compared at this moment. Cracks are obvious in the beam of the cafe and they are progressing inside the walls of the Luggage Check just beneath the cafe (Fig. 13, left). The hotel made temporal reinforcement by timber wood (Fig. 13, right). This deformation due to the ground subsidence are caused by landslide activity just before the cafe. On the other hand, N-9 extensometer showed exceptionally large extension of about 15 mm in the first week and in turn, gradual compression motion of about 4 mm in the next 3 weeks. The N-10 extensometer showed almost no displacement. These two extensometers need further monitoring to judge the instability of this block.

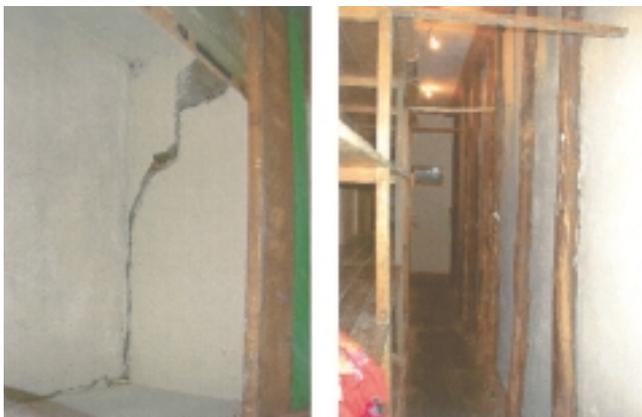
The open cafe in the forecourt of the Machu Picchu Sanctuary Lodge is suffering from ground deformation for years. There are new cracks on the ground, which imply this site is head scarp of a small landslide. Every day a lot of tourist take rest at this cafe and the instability of its foundation must be a serious problem. One set of non-recording type extensometer (N-1) and one set of self-recording type extensometer (S-1) were installed crossing the cracks. The back slope of the Machu Picchu Sanctuary Lodge showed an old landslide topography and two sets of non-recording type extensometers (N-9, N-10) were

Fig.13 Cracks progressing in the wall and their temporal reinforcement by timbers inside the Luggage Check beneath the open cafe of Machu Picchu Sanctuary Lobge

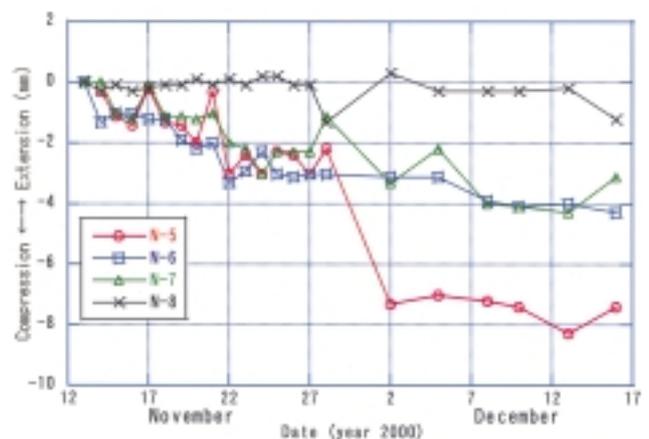
Fig. 14 is the monitoring result of the extensometers N-5,6,7 & 8. Three of the four extensometers show cumulative compression of 4 - 8 mm in about one month. On the other hand, N-8 extensometer shows almost no change. These results strongly imply that the lower steps of the back slope of Intiwatana is unstable and already starts downslope movement.

Fig.14 Monitoring record of the four extensometers installed on the back slope of Intiwatana.
