Landslide Risk Evaluation in the Machu Picchu World Heritage, Cusco, Peru

Kyoji SASSA^{*1}, Hiroshi FUKUOKA^{*1}, Haruo SHUZUI^{*2}, Minoru HOSHINO^{*3}

Keywords: Risk evaluation, Prediction, Monitoring, Precursor stage of landslide

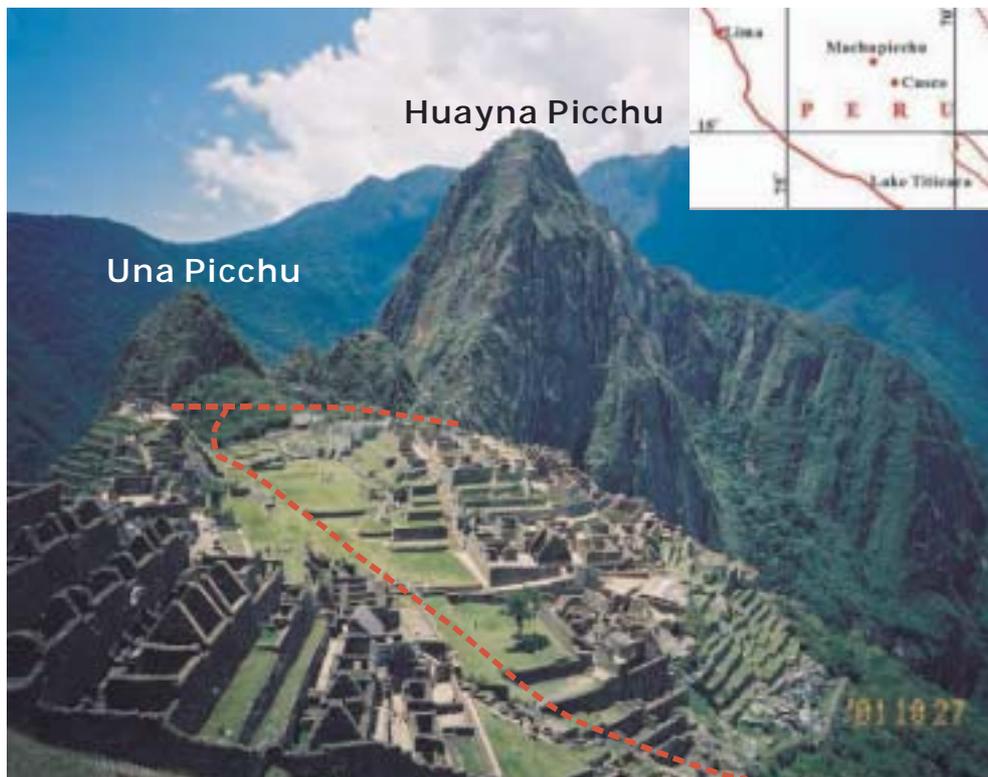
Machu Picchu citadel possibly has been affected by landslides. The photo shown in Fig.1 was taken by H. Shuzui (a member of the Japanese team). You may see a beautiful citadel is constructed on the top of rocky mountain. At the same time, you may find this part of mountain ridge is different from other part of the mountain ridge seen behind the citadel (Una Picchu and Huayna Picchu). The part called as **Plaza** in which the citadel was constructed has a flat area or an even concave area sandwiched by two ridges (Intiwatana in the left side peak in front of Una Picchu and the residential building area in the right side peak). By the eye of landslide researchers, the Plaza area seems to be re-profiled by filling earth or debris to the cracks between two ridges along the dotted line. As shown in the previous report (Sassa et al 2001), the dot line passed through a zone of broken structure in the extension of right bottom of Fig.1. This hypothesis is not yet proved by monitoring, drilling, geophysical exploration or direct excavation or other reliable methods. However, any phenomena to deny this hypothesis is not yet found. Therefore, what is the cause of Plaza geomorphology, which is apparently different from other parts of mountain ridge in this Machu Picchu area, should be investigated.

Fig. 1 Location and view of Machu Picchu Inca citadel on the mountain ridge, Cusco, Peru.

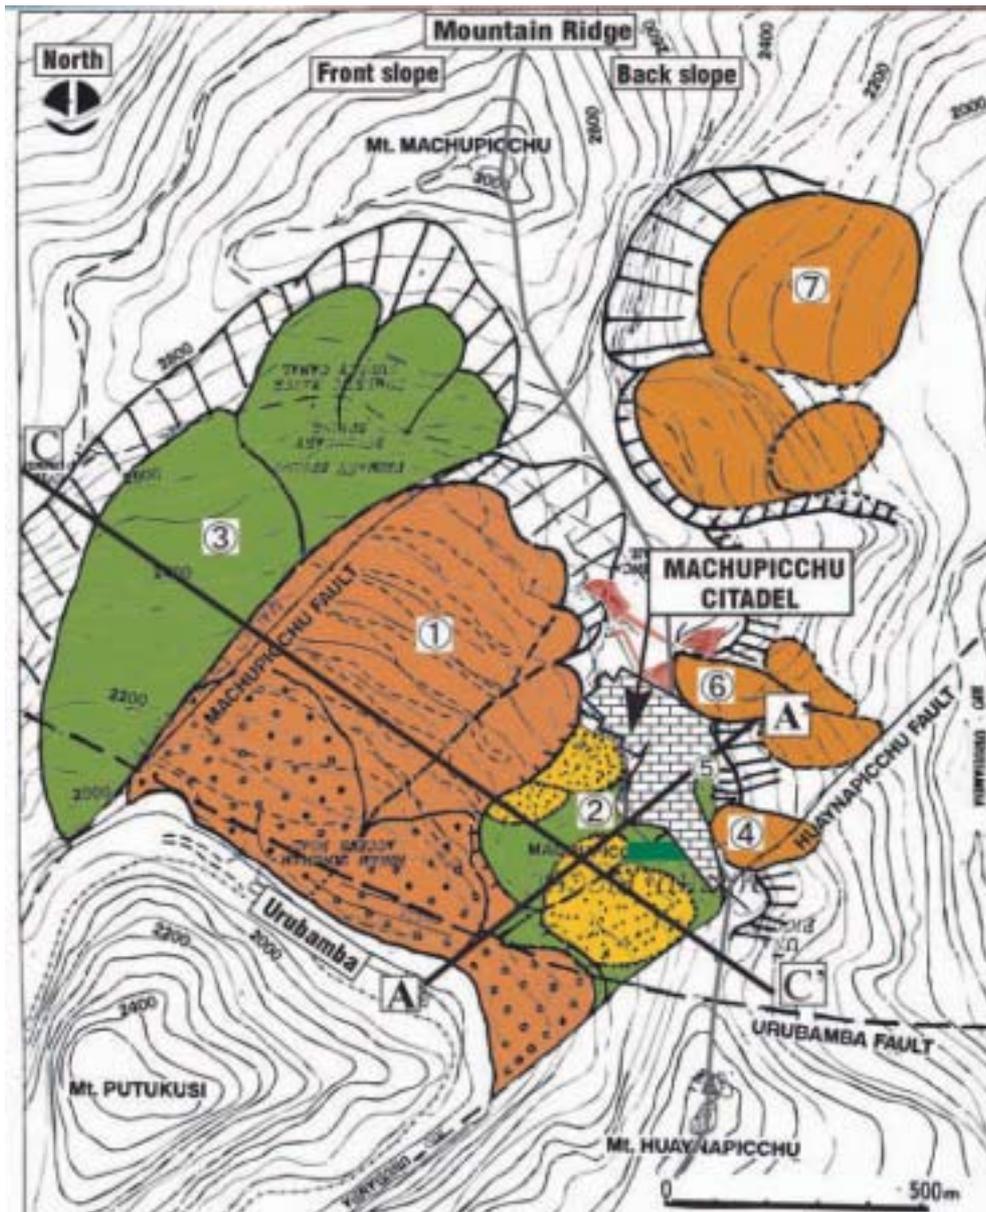
Sassa et al presented a landslide distribution map based on chiefly air photo by Geographical Institute, Peru, 1963 and field investigation from a chartered helicopter and walking in Fig.2. Landslide blocks were drawn on the topographical map used in the report by K. Wright and R. Wright 1997. It is included in Wright and Zengarra, 2000. The ridge connecting Mt. Machu Picchu

and Mt. Huayna Picchu separates the slope as a gentle slope where Hiram Bingham Accessing Road is constructed, and a steep slope. We have called the gentle slope with the accessing road as **Front Slope** including Blocks 1, 2 and 3, and the steep slope as **Back Slope**. In this map, No.1 and No.4, No.6 and No.7 are landslides. No.2 is an area, which may develop to an actual landslide or a landslide at precursor stage. No.5 of Intiwatana area shows some phenomena of ground deformation around them (Sassa et al. 2001). The long-term stability of this area is questionable. No.3 was probably the bottom of previous landslides. All landslide debris slid away there. At present the lower half of slope seemed to be not active.

Fig. 2 Landslides and potential landslides around the Machu Picchu Citadel (Sassa et al.2001)

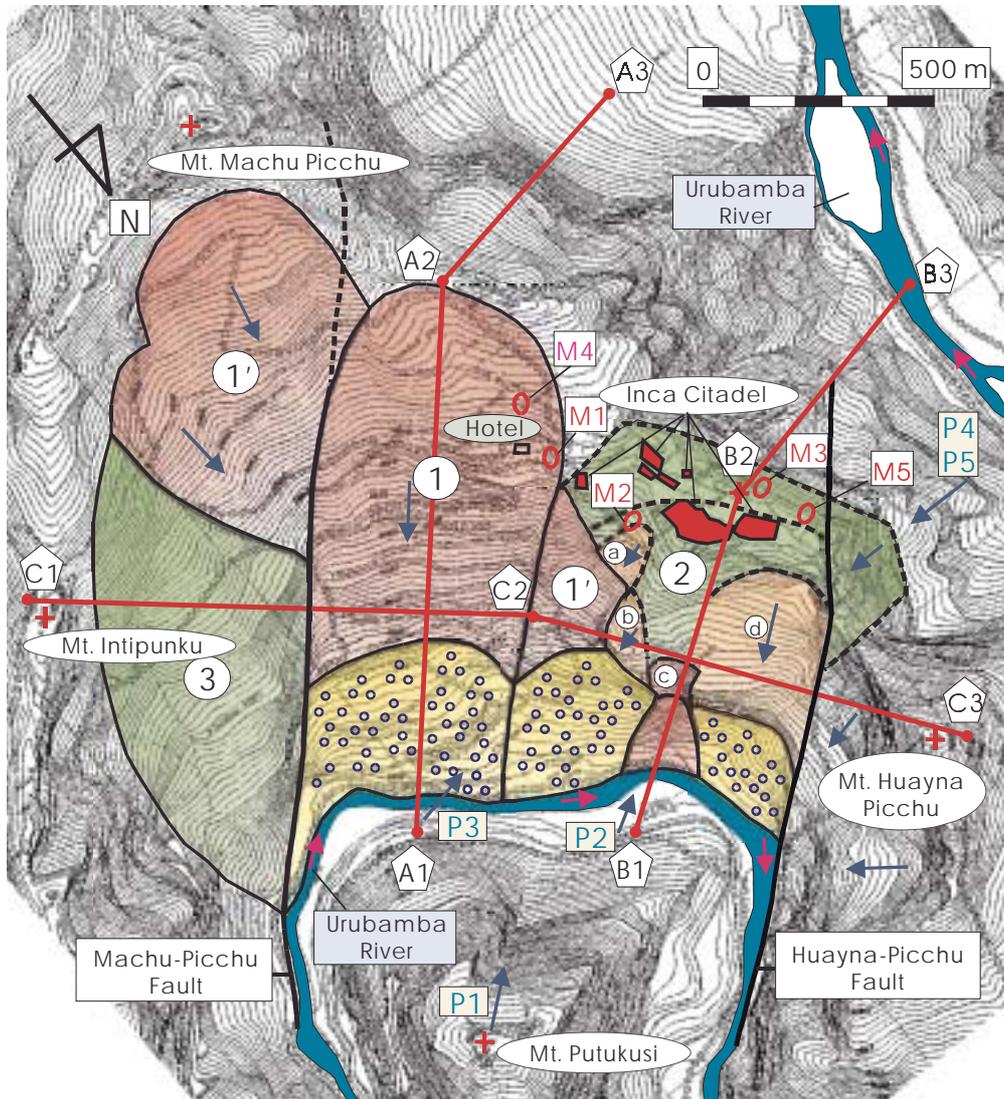
Fig. 3 Working Map of Landslide Blocks 1, 2 and 3 in Front Slope
 (Our interpretation on landslides were written on the basic map of 1/5000
 provided by UGM)
 A1-A3, B1-B3, C1-C3: Lines for Sections for Block 1, Brock 2 and cross
 sections
 ①②③: Blocks of landslides or potential landslides.
 ①': Expanding blocks of Block 1 to Block 2 and 3
 a, b, c, d: Sub-blocks of Block 2 which seem to move up towards the citadel
 area from the border. (a: a retrogressive landslide, b: possible rock
 topple, c: a recent landslide, d: shallow landslides which have not yet
 slid so much.)
 ☼☼☼☼: Landslide debris at the toe of slope
 M1-M5: Locations of extensometers
 P1-P5: Photos of Block 2 from various directions

The authors investigated Machu Picchu area, especially Block No.2 during 24 – 28 October 2001, and examined the site for a series of long span extensometers including a span crossing Plaza in the citadel. Based on this investigation, and 1/5000 map we obtained this time from UGM (Machu Picchu Joint Managing Unit), we modified Fig.2 and made another working map for Block No.1 and Block No.2 as shown in Fig.3. Sites of most information which are referred later in this paper were included in this map, as well.

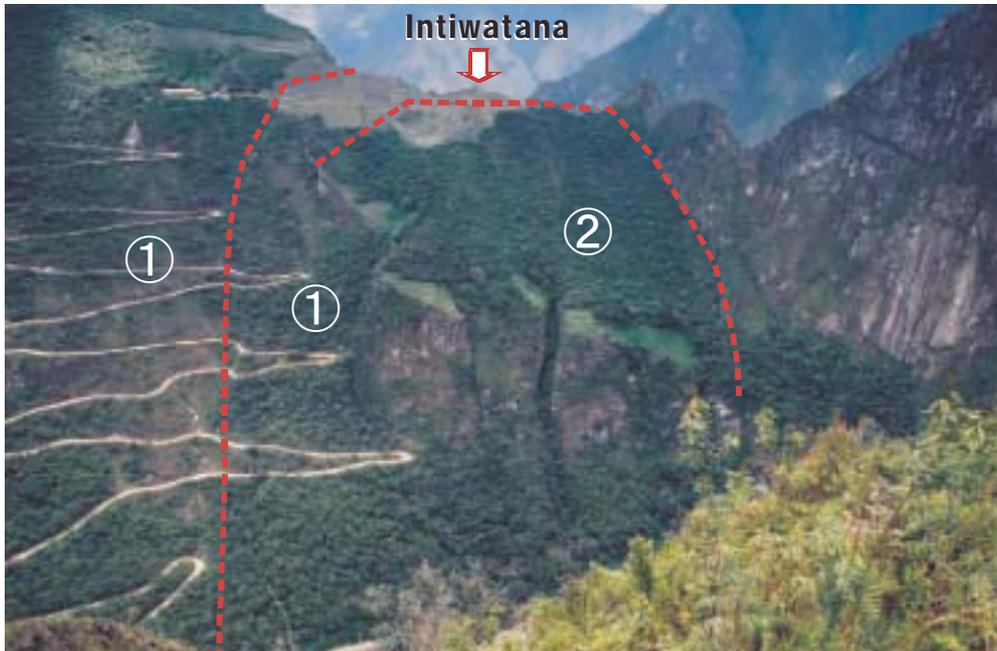
Photo 1 presents a view from the top of Mt. Putukusi toward Block (1), (1') and (2). The color version of this photo is presented in the color gravure. The citadel is constructed on the mountain ridge, Intiwatana is located on its peak in the point of arrow. Sharp cliffs made by landslides (rock slides and rock topples) seem to gradually move upward from the border between (1') and (2) and the toe of slope to the citadel site. Four deep vertical cracks due to faults subdivided Block 2 as you may find some of them in the toe of Block 2 in the photo, especially one crack is very big.

Photo 1 Block No.2 from Mt. Putukusi shooting (taken by H. Shuzui)

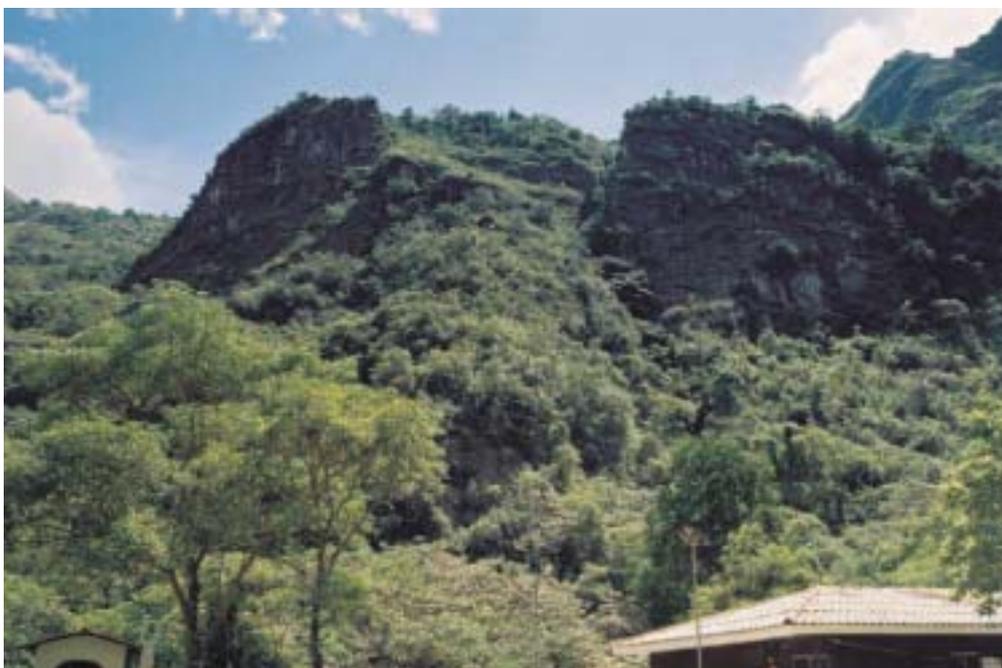
Photo 2 presents the frontal view of sub-landslide (c) from the opposite bank. Easily supposed from the view, the landslide was not yet eroded and keep the original form of landslide mass, and it is not old landslide (the date is not yet confirmed). We set a central investigation line passing this landslide and Intiwatana. This is the most disturbed area of Block 2. **Photo 3** presents a view from the bridge to Block (1') and the sub-block (a) of Block 2. You may find previous landslide debris in front of the head scarp. A concave ground surface of sub-block (a) is seen in front of the citadel, though it is not very clear in this photo. It indicates gradual movement and monitoring by extensometers showed a movement though the records are still very limited.

Photo 2 A recent landslide in the toe of Block 2 from the opposite bank

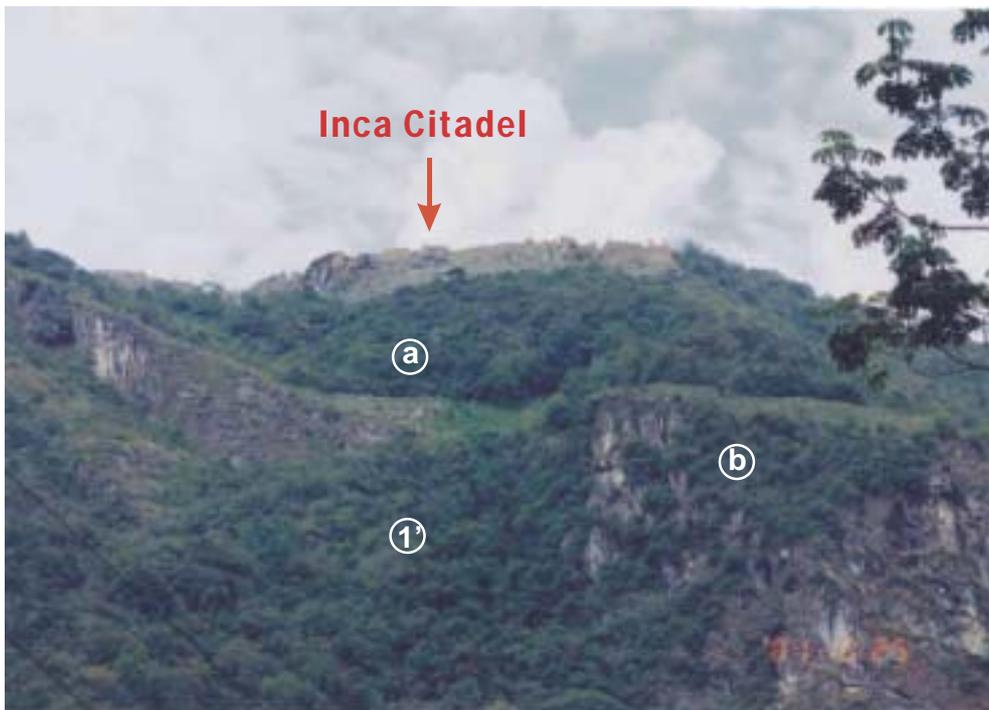
Photo 3 Landslides invading the side of Block 2

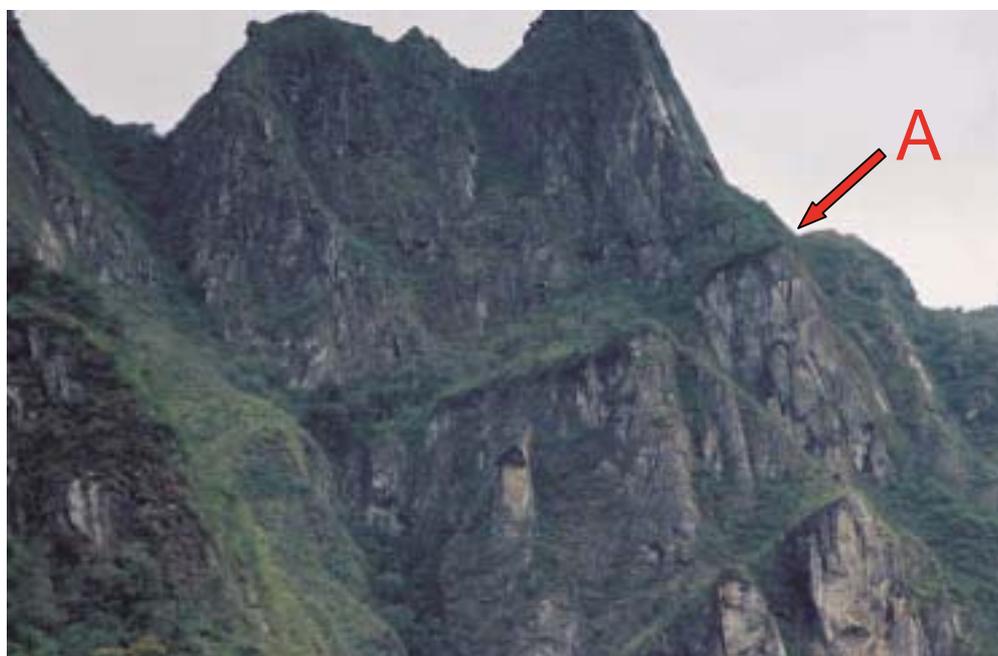
Photo 4 and **5** were taken from the back side of citadel. The arrow A pointed a shear band, which is possibly a potential sliding surface of Block 2. A shear band is gently dipping, and a shear displacement around the shear plane is observed, and furthermore, rocks seem to be slightly dragged below the shear plane. Photo 5 is the close up photo of the shear band. This time we firstly walked around the back slope of Machu Picchu. Therefore, this finding is very important for the planning of further investigation, though it is too early to conclude this shear band (possibly gently dipping fault) as the potential sliding surface of Block 2. However, this is the most likely candidate of the sliding surface at present. The further investigation plan should include the examination of this shear band.

Photo 4 A shear band, possibly the potential sliding surface of Block 2 is visible in the back slope (arrow A)

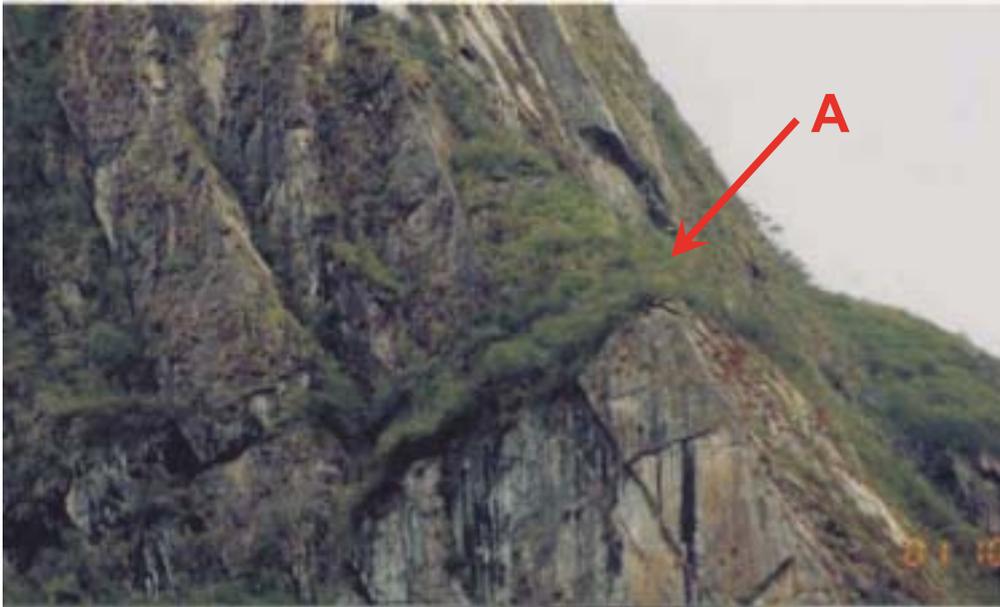
Photo 5 A zoomed up photo of the potential sliding surface (shear displacement at the shear band and toppling deformation below the shear band are visible) taken by K. Sassa

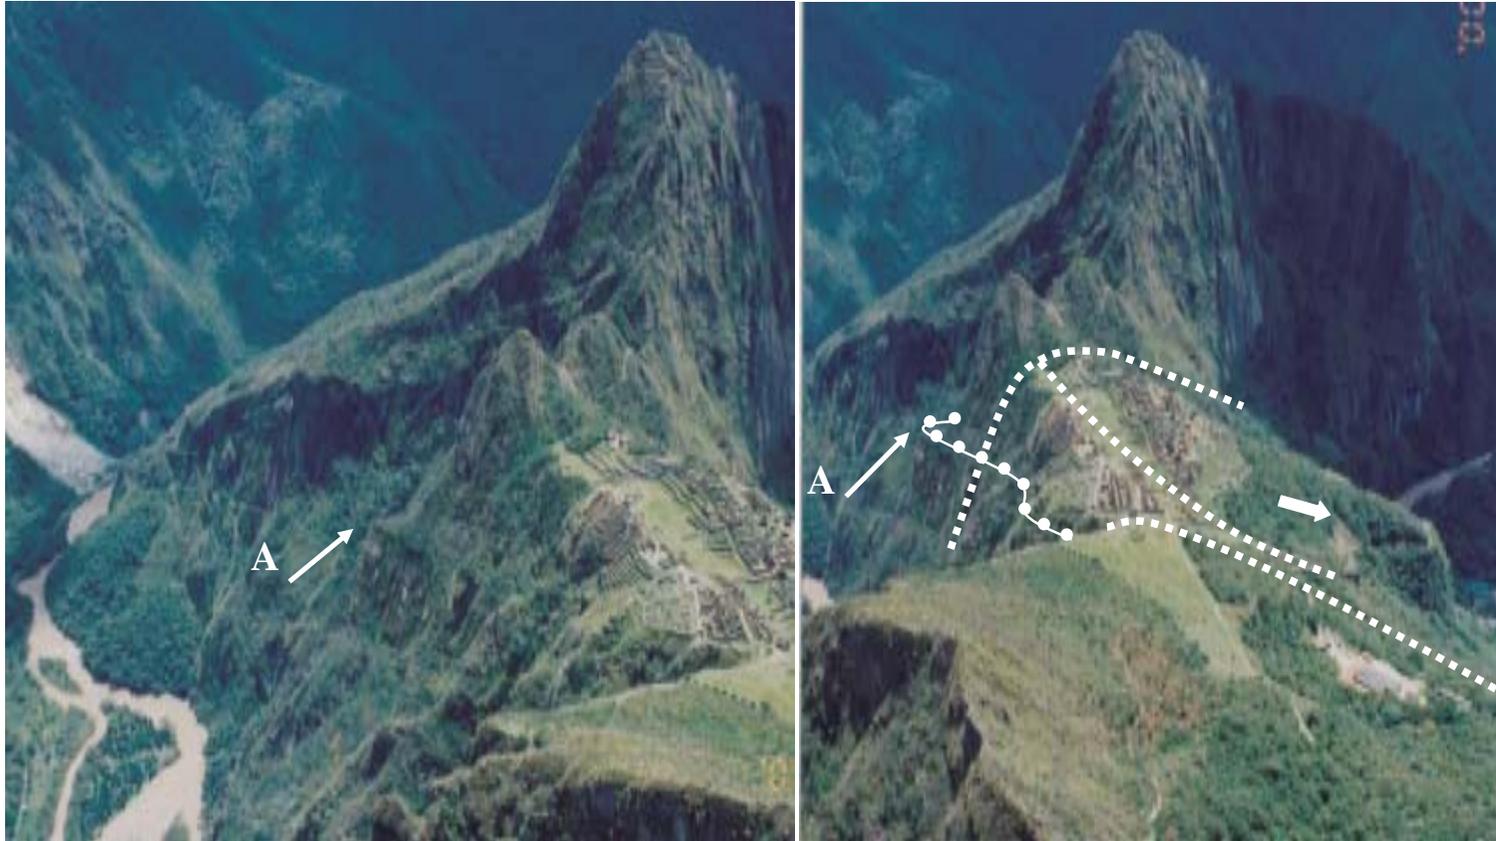
Figure 5 presents two photos taken from a chartered helicopter taken by Kyoji SASSA in March 2000. These two photos gave us another view of this potential sliding surface (arrow A). You will possibly find that this potential sliding surface dips almost parallel to the front slope. The dot line made of round circle (yellow color line in the gravue) points the shear band dipping to the front slope. The dot line made of square mark (red color line in the gravue) shows the possible landslide border of Block 2 on the ground surface. You may notice a landslide debris filling a part of the Urubamba River in the left photo. The landslide debris is gradually flowed out, and such loss of toe support may trigger further landslide as is the common process in many of landslides.

Fig. 5 Photos from a helicopter shooting the potential sliding surface (marked as A) and the potential borders of landslide on the ground surface taken by K. Sassa

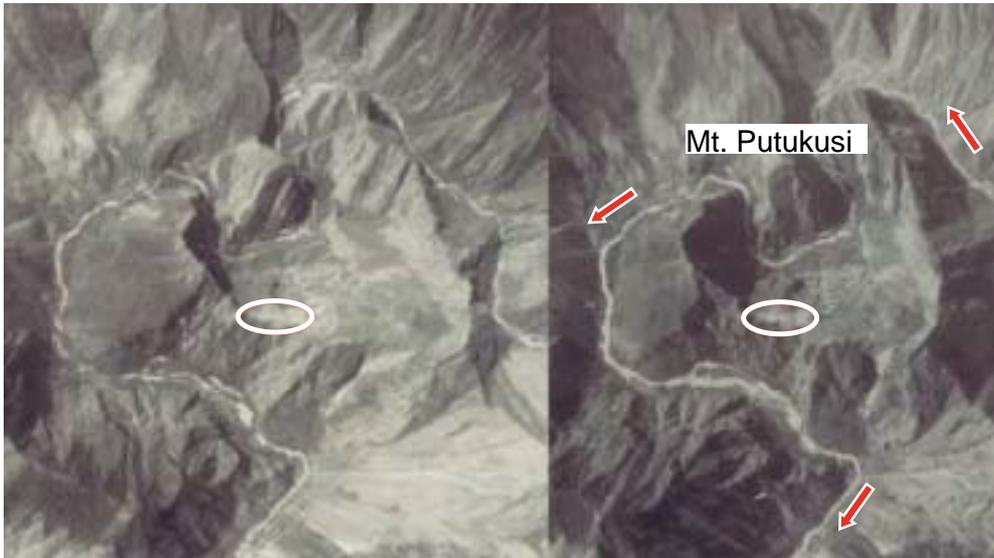
To get the general image, an air photo taken from a high altitude will be the best solution. A stereo pair photos in Fig. 6 presents the location of Machu Picchu citadel (a circled part) and its surroundings. The Urubamba River encircled the Machu Picchu area along the strong fault system. You may find the front slope (Block No.1, 2 and 3 in Fig.3) of Machu Picchu seems to have been excavated by previous mass movements. The mountain ridge of the part of citadel seems to have been subjected to landslides, and partly removed. Mt. Putsukusi is not a part of landslide block. It is a stable rock mass as the whole, though surface rock slides are observed. No great flow-mountain as a result of a big landslide is not seen along the Urubamba River. Therefore, it will be supposed that landslides having excavated the front slope were probably not a single gigantic landslide, but a series of retrogressive landslides so as to be seen in Block 1 at present and in the border of Block 2.

Fig. 6 Airphoto of Machu Picchu (Geographical Institute, Peru)

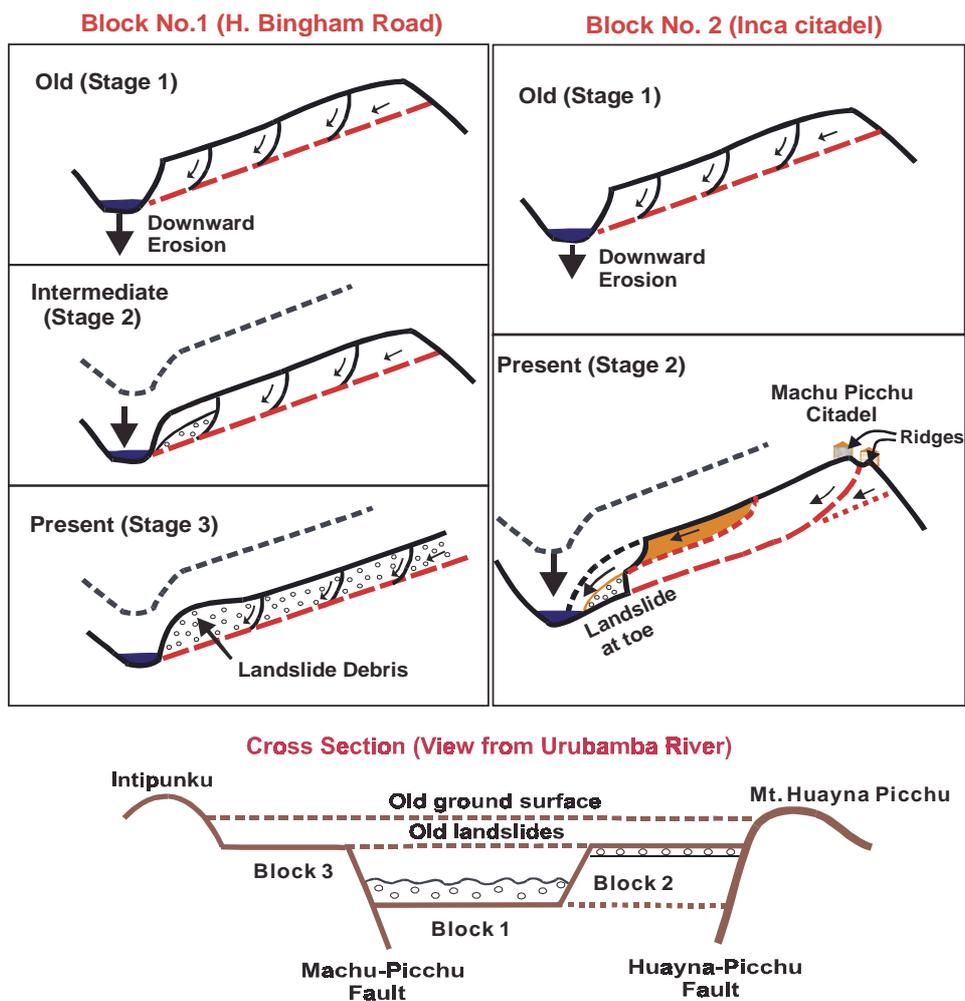
To assess the landslide risk, the process of landslides until the present stage should be correctly understood by the field investigation and interpretation. But the investigation is not enough to conclude the process. However, the draft interpretation was presented in the previous symposium (Sassa et al 2001). Fig.7 shows the second draft of interpretation. The stages of landslide evolution were illustrated for Block 1 and 2 in a schematic form. In the old time, probably retrogressive landslides occurred in the front slope of Machu Picchu. (Some landslides occurred in the back slopes, too. But Block 1 and 2 are examined in this paper.) After the whole landslide debris moved out to the Urubamba River, the downward erosion proceeded. The level of Urubamba River was shifted around one hundred meters downward almost to the present level. Three slopes of Block 1, 2, 3 showed the difference in the landslide evolution. The slope of Block 1 had been most heavily subjected to toe erosion of the Urubamba River as easily

Fig. 7 Hypothesis of landslide process in Machu Picchu

supposed by the curved path of the river and flow direction in Fig.3. Firstly the slope started to slide as illustrated in the intermediate period (Stage 2) of Block 1. The initial landslide retrogressively expanded to the upper slope and toward the side slopes, then the present situation of Stage 3 where active landslide debris covers the slope was formed. You may find in Fig.3 that the Urubamba River was pushed forward by the landslide debris provided by Block 1. So this landslide debris has probably worked for the protection of toe erosion of Block 2. Because of this protection, the evolution of Block 2 was probably much delayed and it is still in the Stage 2. The most delayed block in slope evolution is Block 3. After previous landslide debris moved out, no major landslides occurred because there is almost no river erosion as imagined from Fig.3. The landslide evolution in the cross section is illustrated in the right bottom of Fig.7. Only Block 1 was subjected to major landslides at the present level of Urubamba River and located in the lower elevation which continues to the around present level of the river bed. And Block 2 is now following the process of Block 1. Fig.8 shows the longitudinal section along A1-A2-A3 in Block 1. The depth of landslides is not known, but the whole slope from the mountain ridge to the river is affected by active landslides and covered by landslide debris. Fig.9 presents the longitudinal section along B1-B2-B3 in Block 2. The section B1-B2 shows the active landslide at the toe (c in Fig.3), and others are possibly at the precursor stage. The potential sliding surface will be a shear band found in Fig.4 and Fig.5. If we consider that the potential sliding surface is located in the level as shown in Fig.9, the depth of landslide is around 100-150 m.

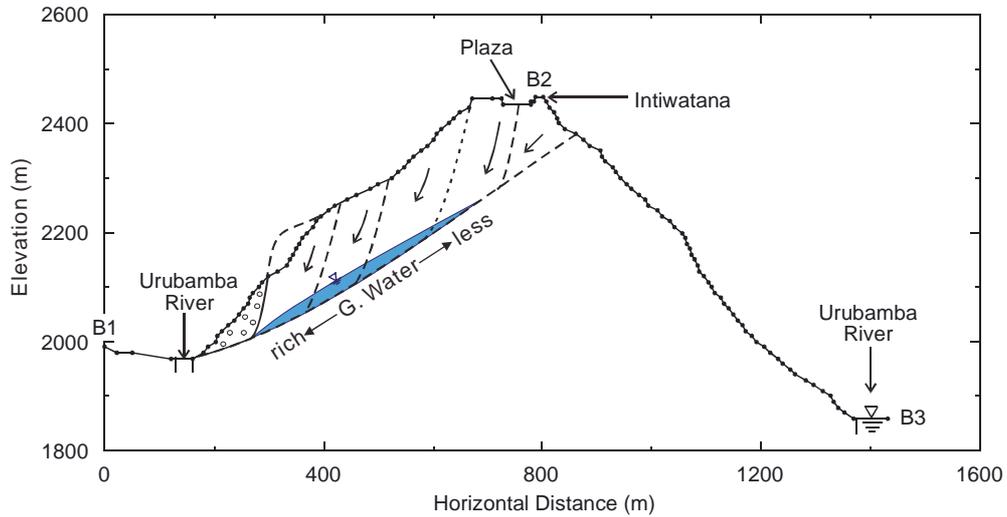
Fig. 9 Longitudinal section (B1-B2-B3) of Block 2

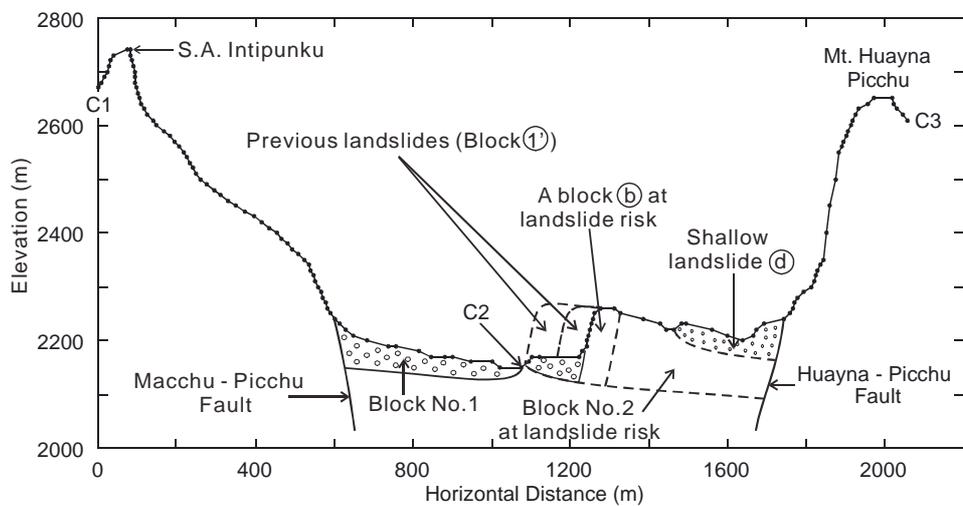
Figure 10 presents the cross section along C1-C2-C3. The potential sliding surface seems to be inclined similar to the ground surface, as shown in photos in Fig.4 and Fig.5 and the plot of the shear band in the topographical map suggests. In this figure, the sliding surfaces of real landslides are drawn by a real line though the depth is not yet confirmed. The sliding surfaces of potential or precursor stage of landslides are drawn by a dot line.

The ground water will increase in the lower part of the slope collecting ground water from the upper slope because the shear band is probably having a low permeability and dipping parallel with the front slope. As shown in the cross section C1-C2-C3 in Fig.10, the shear band is gently dipping to the Huayna-Picchu fault side. It means that ground water flows from Block 1 or 1' to Block 2. Therefore, probably the ground water level and pore water is greater in the lower part of Block 2, and almost no ground water near the top of slope. In this case, the top of Block 2 (area of Plaza and Intiwatana) is rather stable, so tensile stress should act in this zone. Accordingly tension cracks may be formed. The concavity in the Plaza likely corresponds to the tension crack, though the concavity was filled possibly by Inca's people for flatter ground suitable for their living, which is not clearly visible on the ground surface at present.

Fig. 10 Cross section (C1-C2-C3) of the front slope of Machu Picchu

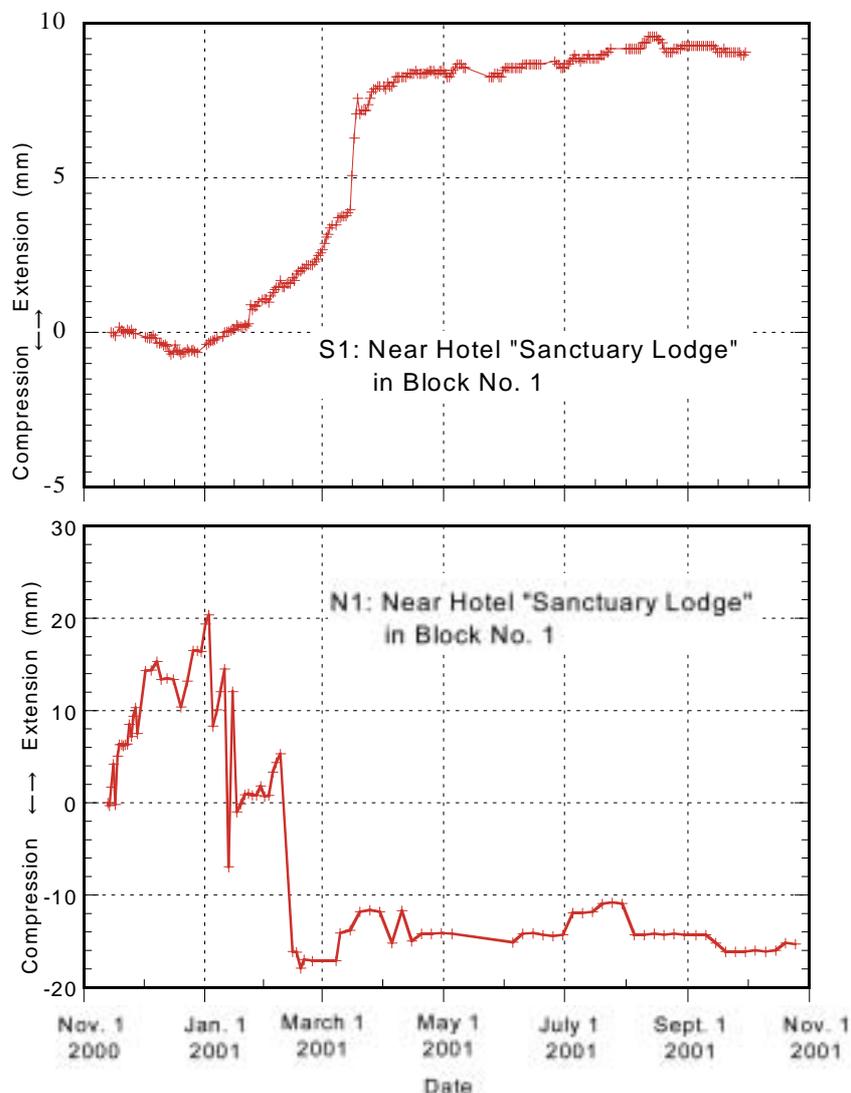
Fig. 13 Records of extensometers (S1 and N1) in the monitoring site (M1) near Hotel Sanctuary Lodge in Block 1

monitor the landslide movement. 12 extensometers were installed in five sites (M1-M5) as shown in Fig. 3. Fig. 13 presents the monitoring results of M1 near the hotel Sanctuary Lodge in Block 1. The extensometer S1 showed gradual extension over a long term, while N1 showed compression after extension from Nov.1 2000 to Nov. 2001. Movement of N1 is rather great. N1 is the manual recording type, and S1 is the paper recording type.

Movement of both extension and compression in the same extensometer is interpreted using Fig.12. When a single extensometer is installed as extensometer B in the figure, extension means the movement of sliding block 1, and compression means the movement of sliding block 2. Movement of sliding block 1 decreases the support of sliding block 2 when two blocks are interconnected. Probably extensometer records of N1, and S1 detect the movement of some of sub-block in Block 1.

Figures13-15 present monitoring records of the short span extensometers, and not a series of extensometers as shown in Fig.12. Therefore, the landslide size is not estimated only by those data. However, comparing those data, the recorded movement of S1 shows a gradual movement from January to the early April, though almost extensometers presented the termination of major movement before early March. The movement detected by S1 is probably due to a deep seated landslide. It must be checked by further monitoring.

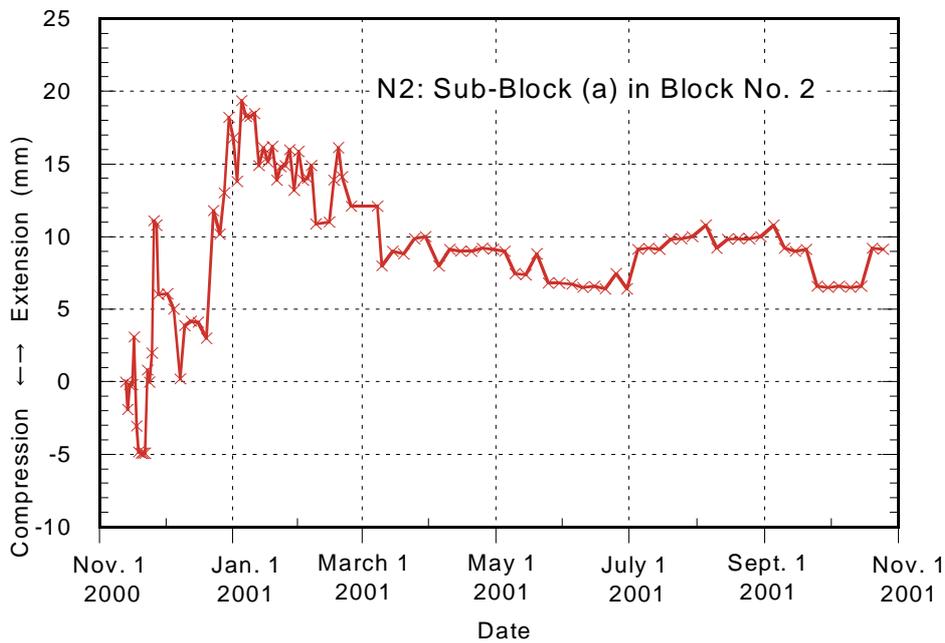
Fig. 14 Records of extensometer (N2) in the monitoring site (M2) in Sub-Block (a) in Block 2

Figure14 presents the monitoring of N2 installed in the border of sub-block (a) of Block 2. The movement is rather great in the order of 10 mm. Fig.15 presents the monitoring results of four extensometers installed in the steps (terraces) for farming in the back slope of Intiwatana. In this part, a debris flow occurred probably in 1999 or 2000 and the fresh trace of debris flow was observed from a chartered helicopter in March 2000. These extensometers are planned to detect the possible retrogressive landslides near the source area of the debris flow. Therefore, those extensometers were not aimed to detect a deep seated landslide, but shallow surface landslides. Those do not affect the Inca's citadel, but it is good exercise to monitor the ground surface movement, and good to totally check the precision, reliability and problems of monitoring.

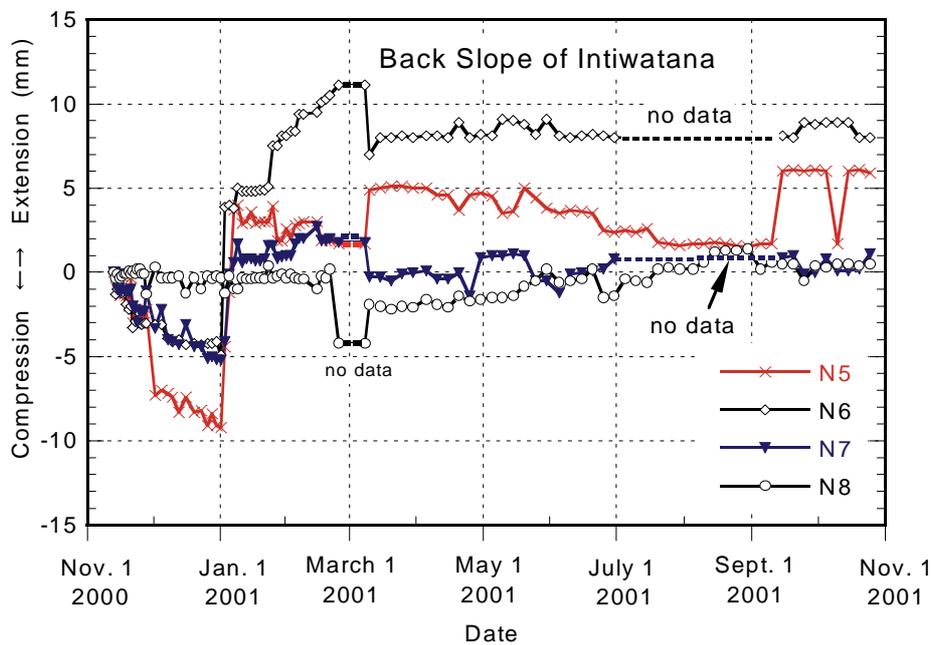
Fig. 15 Records of extensometers (N5,N6,N7,N8) in the monitoring site(M3) in the back slope of Intiwatana

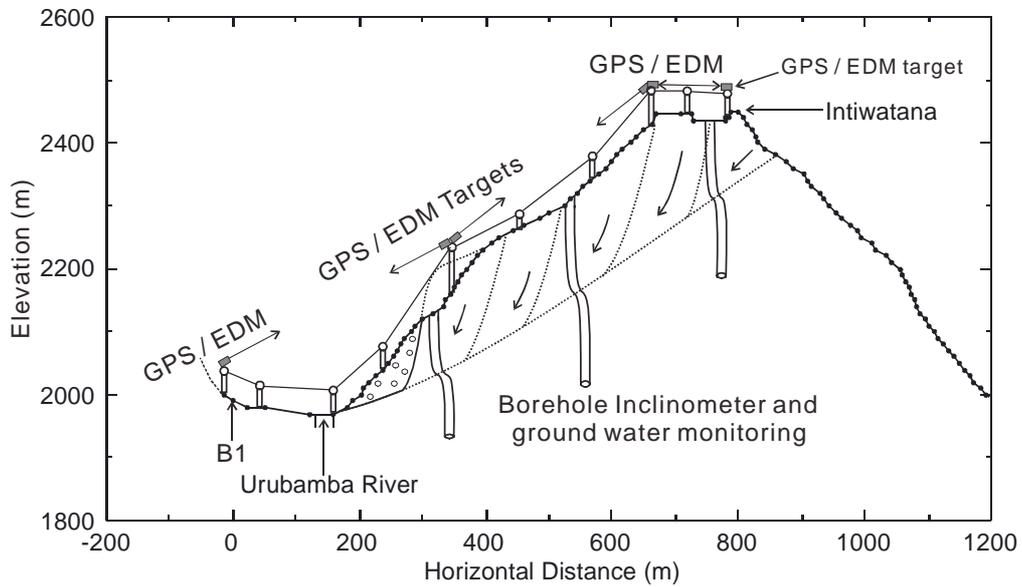
Fig. 16 Illustration of monitoring system for the precise understanding of potential landslides

The results of field investigation and monitoring suggest the possibility of landslides, which possibly affect the Inca's citadel. The exact understanding of slope conditions and landslide risk evaluation need further investigation. Fig.16 illustrates a monitoring system to be employed in Block 2. A series of extensometers from the Intiwatana (top of the slope) to the opposite bank of Urubamba river is desirable to assess the location and size of landslide and its danger reaching to failure. Monitoring result by a single method is better to be examined by other methods. EDM and GPS methods are appropriate to be applied. GPS has a merit of movement monitoring in wider area because their sets can be installed over the Block 2. EDM has a merit of very long span of monitoring, though both are affected by atmospheric conditions. However, combination of those methods and their integrated interpretation should present reliable results. Drilling and the borehole inclinometer or alternative methods to detect the sliding surface are very necessary to know the depth of landslide. Ground water monitoring is necessary to evaluate the effect of ground water on this landslide.

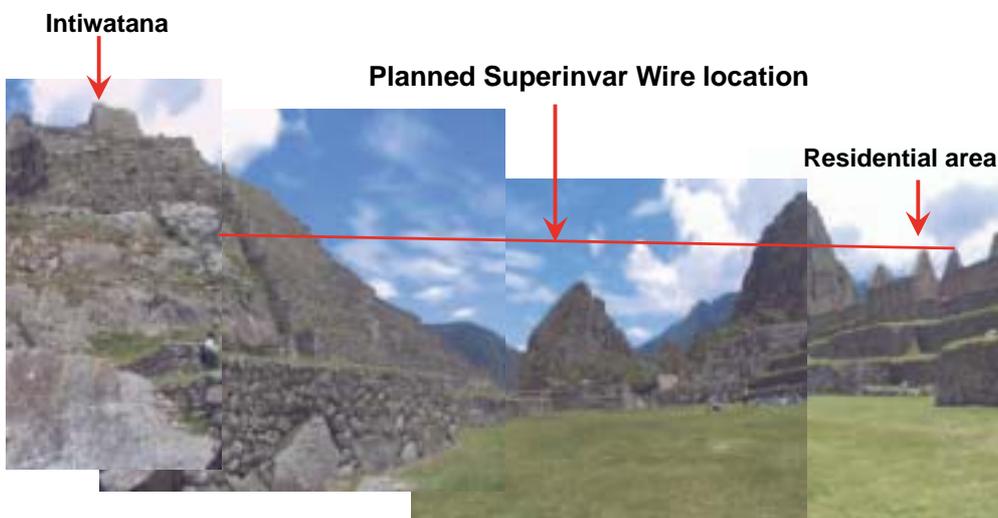
Fig. 17 Photo of a planned super invar wire location crossing the Plaza.

Finally the photo of the first long span extensometer to be installed crossing Plaza is shown in Fig.17. With cooperation from engineers of INC and INRENA, our team examined the site for a long span extensometer and conducted a trial installation, though the super invar wire and a long span extensometer were not yet installed. However, we have checked that such installation is possible with almost no disturbance of scenery of Plaza under the examination of the archaeologists working for the Machu Picchu World Heritage. A super invar wire is 1.0 mm in diameter though the line was drawn in a visible way in Fig.17, and it is passing high above the walking visitors.
