# LANDSLIDE RISK AT INCA'S WORLD HERITAGE IN MACHU PICCHU, PERU

## 世界遺産マチュピチュにおける地すべり危険度評価

Kyoji SASSA, Hiroshi FUKUOKA, Toshitaka KAMAI and Haruo SHUZUI

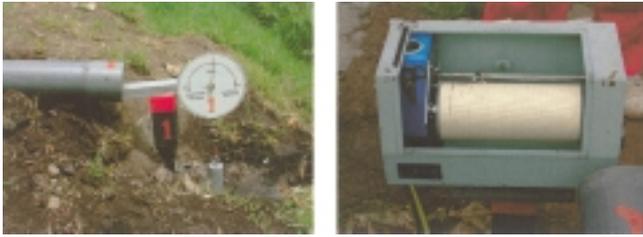
Fig. 8 Two types of extensometers installed in Machu Picchu citadel. Left: Simplified type extensometer (#1 in Fig. 9) which was developed for monitoring of active / potential landslides in Machu Picchu citadel. Right: Self-recording type extensometers (S-1 in Fig. 9).

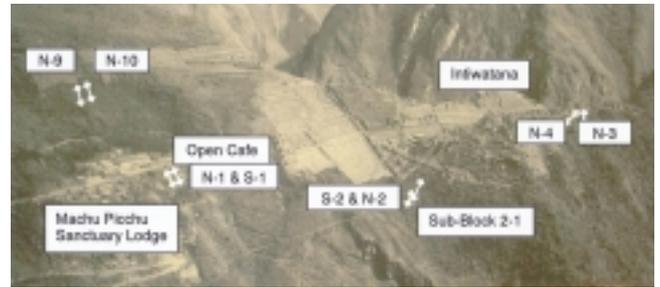
Fig. 9 Location of extensometers in the Front Slope of Machu Picchu citadel.

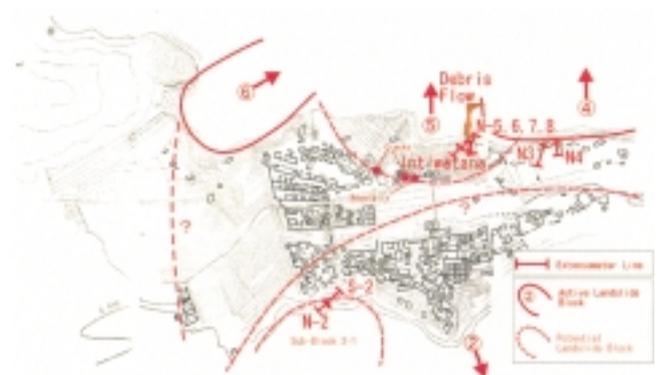
Fig. 2. A line of cracks and deformation of structure (Principal Temple) was found in other side. Therefore, the block that includes Intiwatana is expressed as a potential landslide block (No. 5) in Figs. 4, 6 and 11.

Fig.11 Plan map of Machu Picchu sitadel showing active / potential landslide blocks and location of extensometers. "N-3" shows exetnsometer No.3 of non-recording type. "S-2" shows extensometer No.2 of self-recording type.
