Landslide Risk Evaluation in the Machu Picchu World Heritage, Cusco, Peru

Kyoji SASSA^{*1}, Hiroshi FUKUOKA^{*1}, Haruo SHUZUI^{*2}, Minoru HOSHINO^{*3}

Keywords: Risk evaluation, Prediction, Monitoring, Precursor stage of landslide

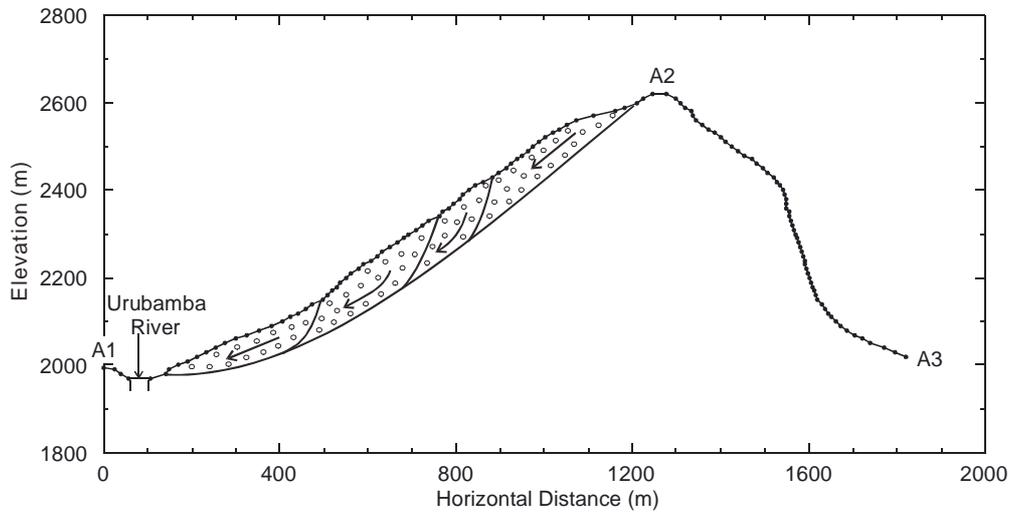
Fig. 8 Longitudinal section (A1-A2-A3) of Block 1

supposed by the curved path of the river and flow direction in Fig.3. Firstly the slope started to slide as illustrated in the intermediate period (Stage 2) of Block 1. The initial landslide retrogressively expanded to the upper slope and toward the side slopes, then the present situation of Stage 3 where active landslide debris covers the slope was formed. You may find in Fig.3 that the Urubamba River was pushed forward by the landslide debris provided by Block 1. So this landslide debris has probably worked for the protection of toe erosion of Block 2. Because of this protection, the evolution of Block 2 was probably much delayed and it is still in the Stage 2. The most delayed block in slope evolution is Block 3. After previous landslide debris moved out, no major landslides occurred because there is almost no river erosion as imagined from Fig.3. The landslide evolution in the cross section is illustrated in the right bottom of Fig.7. Only Block 1 was subjected to major landslides at the present level of Urubamba River and located in the lower elevation which continues to the around present level of the river bed. And Block 2 is now following the process of Block 1. Fig.8 shows the longitudinal section along A1-A2-A3 in Block 1. The depth of landslides is not known, but the whole slope from the mountain ridge to the river is affected by active landslides and covered by landslide debris. Fig.9 presents the longitudinal section along B1-B2-B3 in Block 2. The section B1-B2 shows the active landslide at the toe (c in Fig.3), and others are possibly at the precursor stage. The potential sliding surface will be a shear band found in Fig.4 and Fig.5. If we consider that the potential sliding surface is located in the level as shown in Fig.9, the depth of landslide is around 100-150 m.

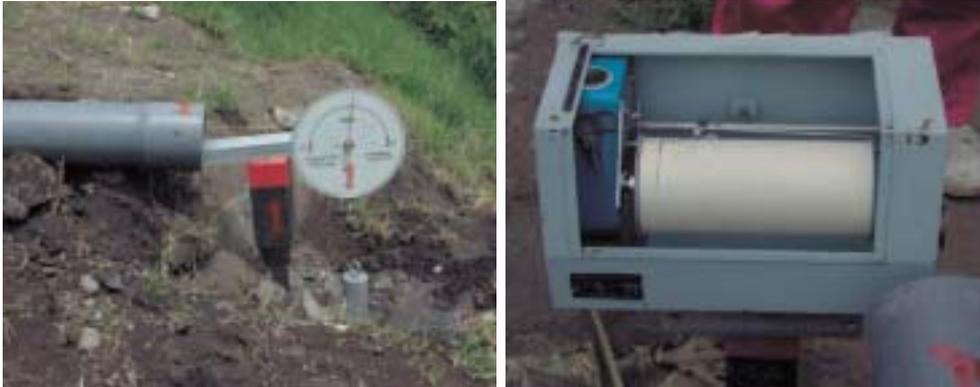
Fig. 11 Two types of extensometers

As the first step of quantitative investigation, two types of simple extensometers were installed in the Machu Picchu slope. One is a handmade manual reading extensometers as shown in the left photo of Fig.11. Using a pulley and a super invar wire (a special kind of metal with least influence of temperature), movement of the distance between two points is mechanically enlarged by 5 times and indicated on the dial with a pointer. Another type is theoretically the same,

movement was also mechanically enlarged by 5 times, and it is recorded on a recording paper continually. The recording drum is rotated by landslide movement, while the recording pen shifts in a steady speed by a dry battery from the left to the right as shown in the right photo of Fig.11.

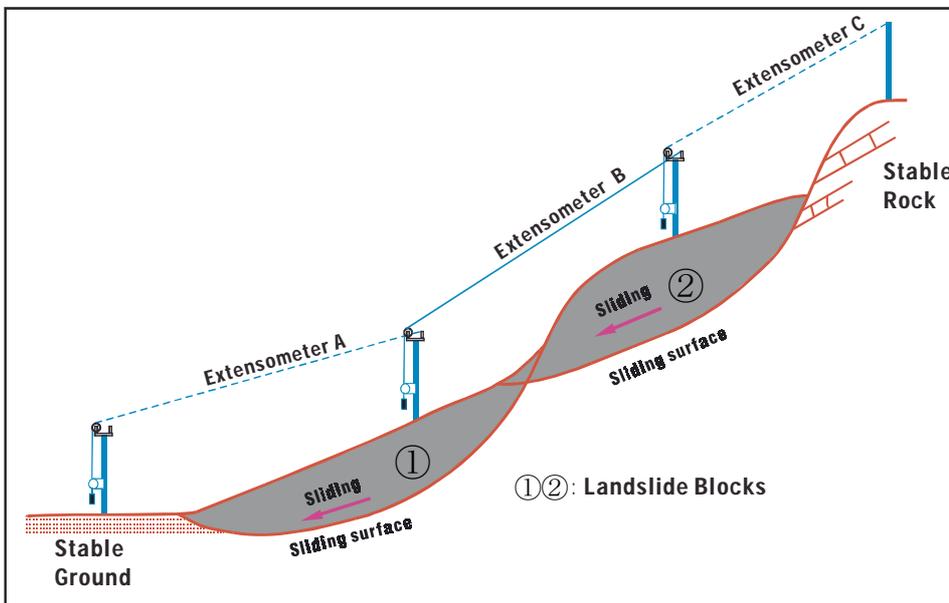
Fig. 12 Illustration of the concept of extensometers

The concept of extensometer is illustrated in Fig. 12. The height of poles for extensometers is different on the length of span of two poles. When monitoring by a long span, high poles are used to pass the super invar wire over trees and roads, and to avoid possible disturbance by animals and persons. While in the case of monitoring in a short span (which is usual case), low poles are used and the super invar wire is protected by a pipe as shown in Fig.11. Extensometers have merits, which are not affected by moisture, density or atmospheric pressure in the air and cause less trouble and very reliable because of very simple mechanical recording system. They are different from sophisticated monitoring systems such as EDM (electronic distance meter) and GPS (global positioning system).

Movement of both extension and compression in the same extensometer is interpreted using Fig.12. When a single extensometer is installed as extensometer B in the figure, extension means the movement of sliding block 1, and compression means the movement of sliding block 2. Movement of sliding block 1 decreases the support of sliding block 2 when two blocks are interconnected. Probably extensometer records of N1, and S1 detect the movement of some of sub-block in Block 1.
